# SUPER MAXI-FLO SUCTION INSTALLATION INSTRUCTIONS

For Model Number: 640-800x V

VGB  
2008

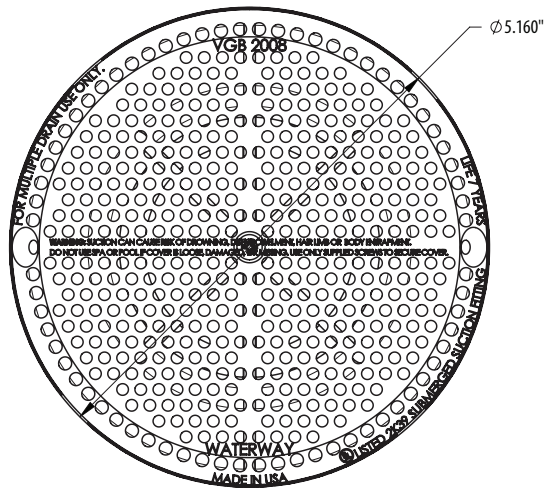
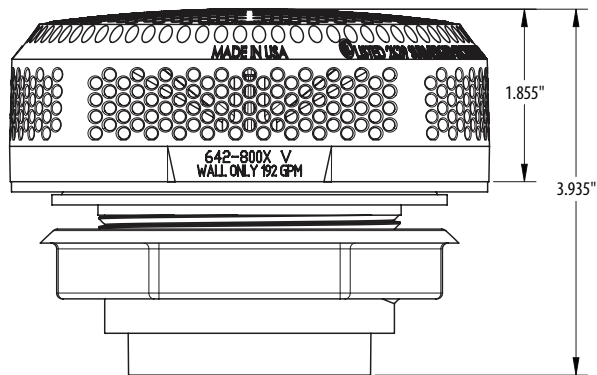
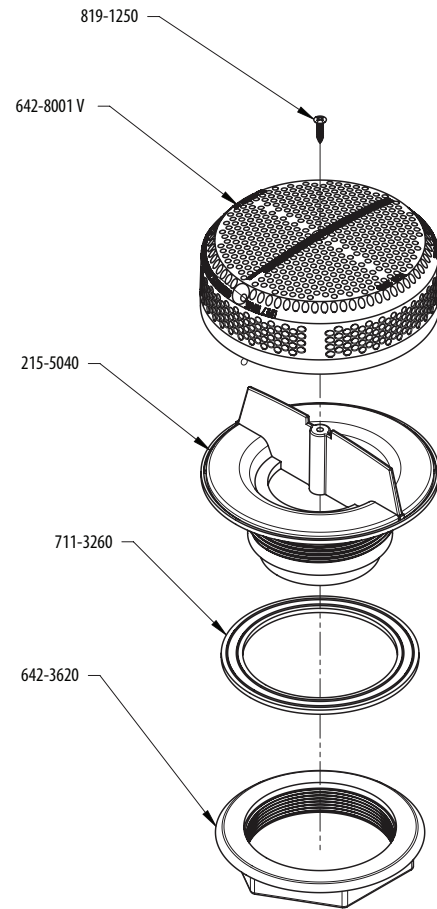
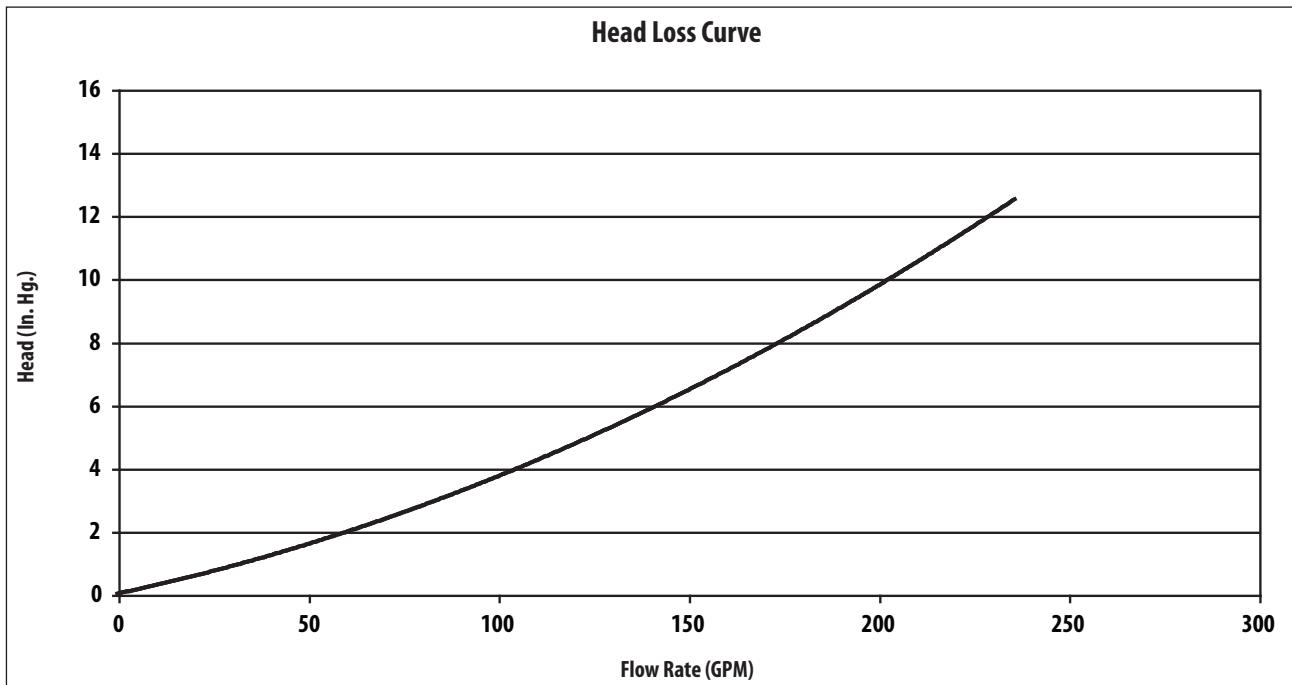
1. Locate and cut a 3 ¼" hole in a vertical wall of the spa. Be sure the area located is flat and spa laminate thickness is uniform.
2. Insert wallfitting with gasket through hole.
3. Apply a bead of silicon against the back wall of the spa and around the threads of the wall fitting . Avoid getting sealant on gasket.
4. Install nut and tighten. Be sure wallfitting screw studs are horizontal to bottom of spa.
5. Glue elbow supplied with fitting into wallfitting. Be sure to orient the elbow in the required direction while gluing.

**WARNING: This is a PVC to PVC connection. Improper gluing or improper cement selection can cause leaks at glued connection which can result in property damage.**
