ULTRA HI-FLO SUCTION INSTALLATION INSTRUCTIONS

For Model Number: 640-349xV

**VGB
2008**

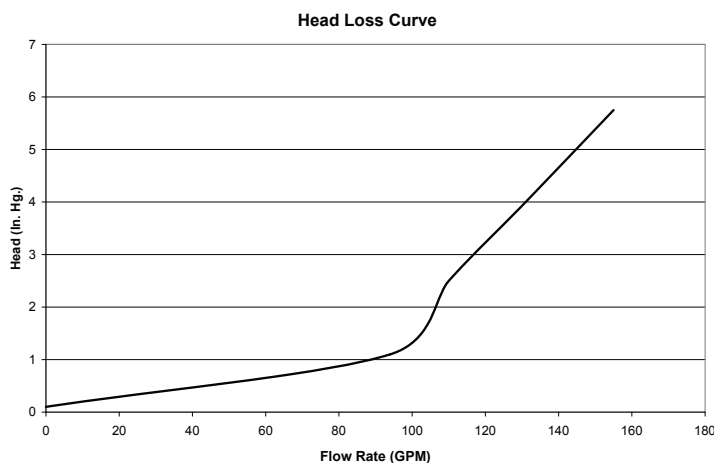
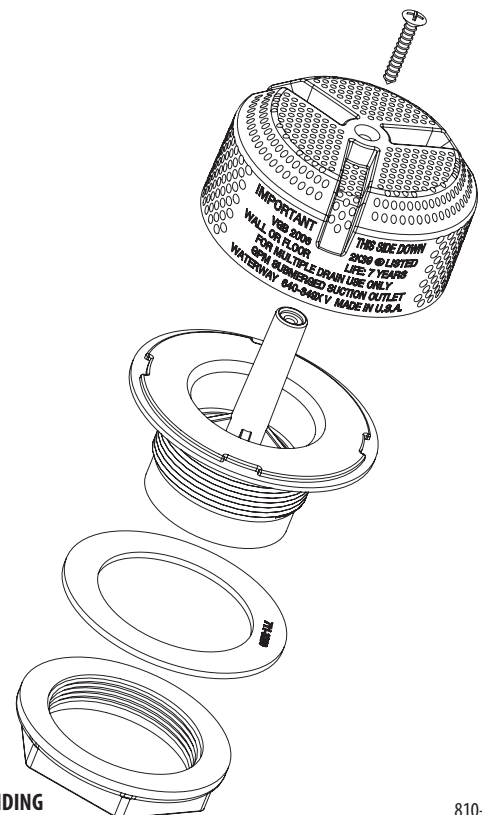
1. Locate and cut a 2 3/8" hole in a vertical wall of the spa. Be sure the area located is flat and spa laminate thickness is uniform.
2. Insert wallfitting with gasket through hole.
3. Apply a bead of silicon against the back wall of the spa and around the threads of the wall fitting. Avoid getting sealant on gasket.
4. Install nut and tighten. Be sure the side with no openings faces to the bottom of the spa. Please refer to the markings on the suction cover for proper orientation of the suction cover.
